Manhole Inspection Summary

Manhole # S39AA_034MH

Location Address: **820 harford ct**

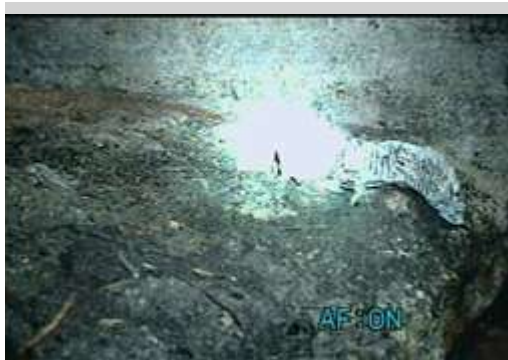
Defect 5

Condition: ☐ Sound ☐ Cracked ☐ Root Intrusion ☒ **Deteriorated** ☐ Leaks ☒ **Debris**

deteriorated bench, bench debris

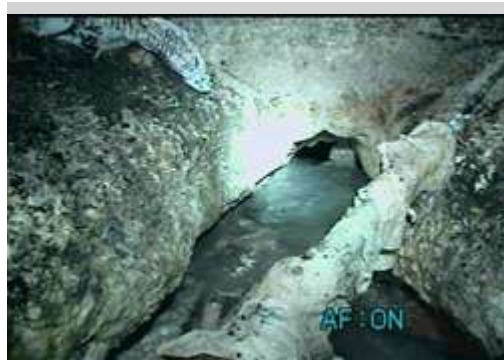
Defect 4

channel debris

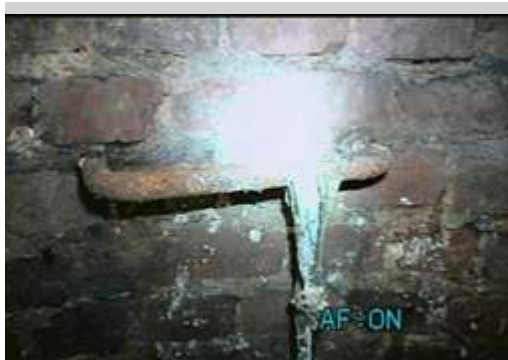
Defect 3

☒ **Evidence Of Surcharge** Depth: **5.** (ft.) ☐ Active Surcharge Present

evidence of surcharge

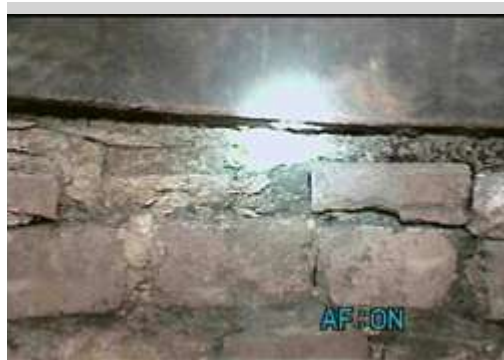
Defect 2

Condition: ☐ Sound ☐ Cracked ☐ Root Intrusion ☒ **Loose Brick** ☒ **Deteriorated**

losse bricks, deteriorated chimney, frame adj

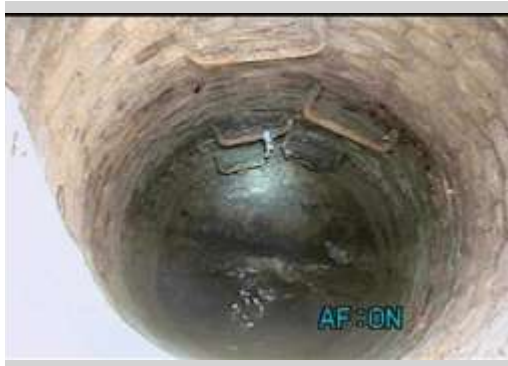
Defect 1

Count: **5** Missing: **0** ☒ **Corroded**

steps
